Workzone Speeds are Up

Health & Safety must come first.

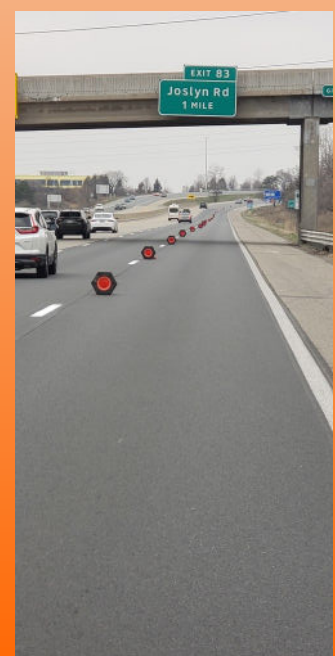
An incident occurred Saturday on I75 where a motorist crashed into the TMA follow truck protecting a groover. The motorist was not paying attention and driving recklessly. Fortunately, the attenuator did its job and no one was injured in the crash. Excessive speed was a factor.
